# Optimized Strategy for Scaling Up Deep Energy Retrofit

## West Hill House

Revised with Data Monitoring: February 11, 2013

Revised with Updated Costs: February 25, 2013

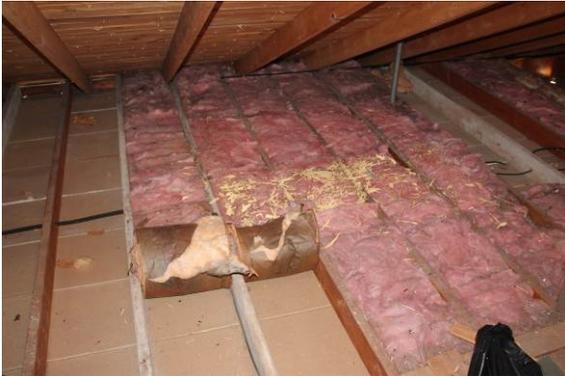
*Attic insulation removal in progress.*

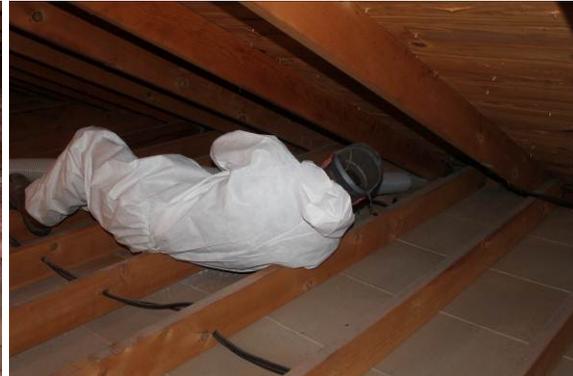
*Using the insulation vac to remove the last of the attic debris.*

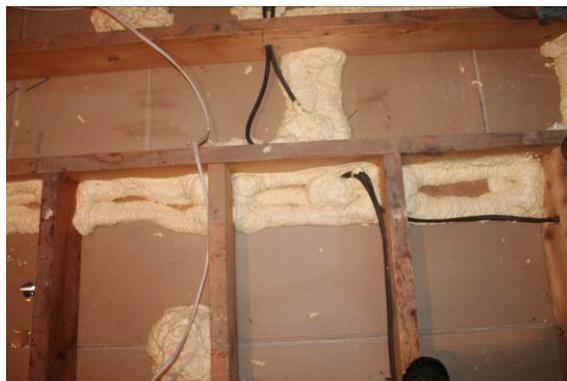
*Spray foam used to seal top plates and electrical penetrations.*

- a) Top plates. Interior and exterior top plates were sealed with a coat of 2-part polyurethane foam. This sealed sheetrock/top plate junctions and wiring penetrations. On the exterior bearing walls, the top plates were sealed to the exterior foam sheathing, which extended between the rafter tails up to the vent chutes to form a wind block.

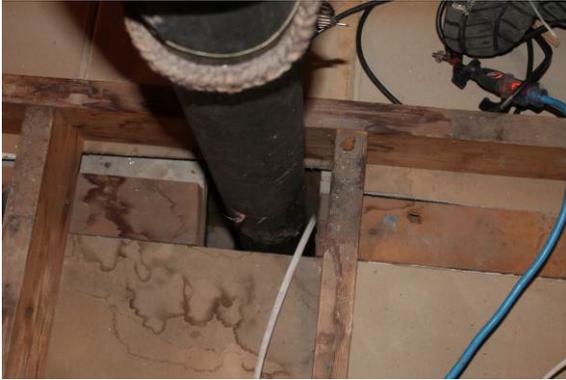
*Plumbing vent with air leaks.*

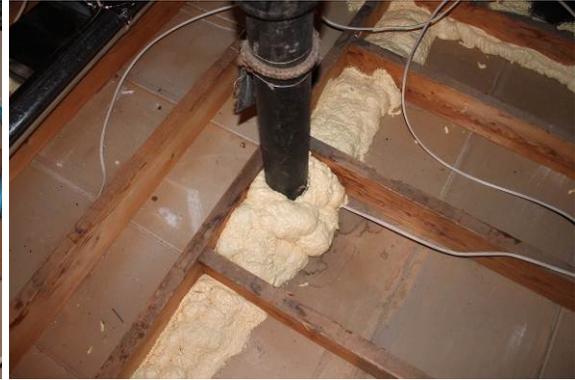
*The plumbing vent is now sealed.*

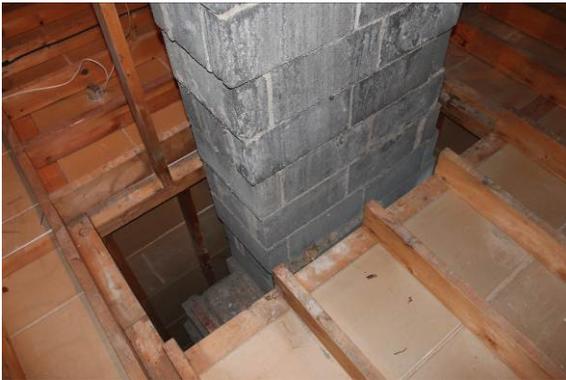
- d) Range hood vent, which passed through a roughly cut hole in the sheetrock.
- e) Bath fan and ERV housings.
- f) A very large chase around the CMU chimney, which housed both the fireplace flue and the old boiler flue. This chase, while originally covered with faced fiberglass, connected directly to grilles in the first floor wall on either side of the fireplace. Additional framing was installed to support a Thermax air barrier at ceiling level, which was sealed with two-part foam. Sheet metal and high-temperature caulk were used within 2" of the chimney itself.

*A giant air leak around the chimney.*

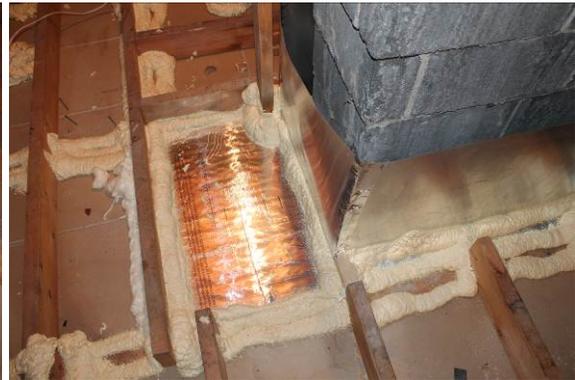
*Chimney air sealed; metal dam provides 2" clearance between cellulose and chimney.*

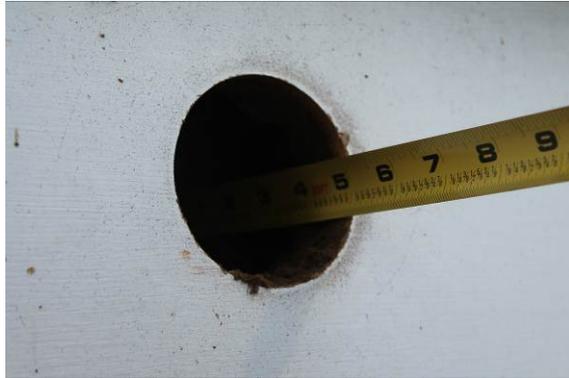
With the exception of the garage wall, which contained some perlite and fiberglass, and the wall behind the kitchen sink, which contained a few pieces of fiberglass, the main floor wall cavities were empty.

*The 2 x 4 wall cavities on exterior walls were completely empty.*

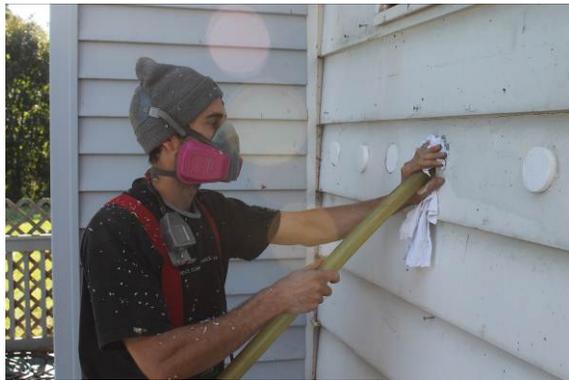
*Dense-packing the wall cavities.*

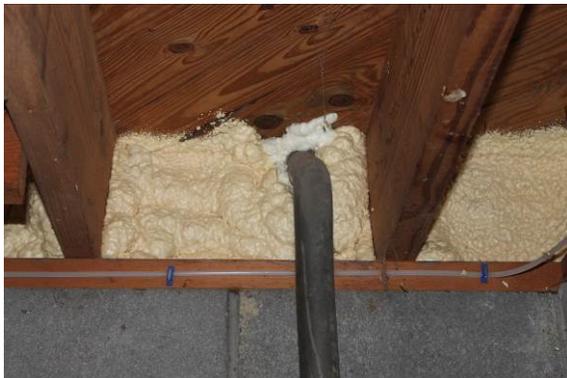
The basement band joist/sill plate assembly consisted of 2 x 8s on a CMU foundation. Small leaks were detected around the entire perimeter at points of wood/wood contact. Larger leaks were found at places where power, telecommunications, and radon utilities passed through the band joist. The band joist was sealed and insulated with 2" closed cell foam. The sill plate was left exposed to allow drying to the inside; however, the wood/CMU joint was sealed with one-part foam.

*Spray foam in basement rim joist. In this photo, Thermax has not yet been installed on the walls, and the sill plate has not yet been sealed to the block foundation.*

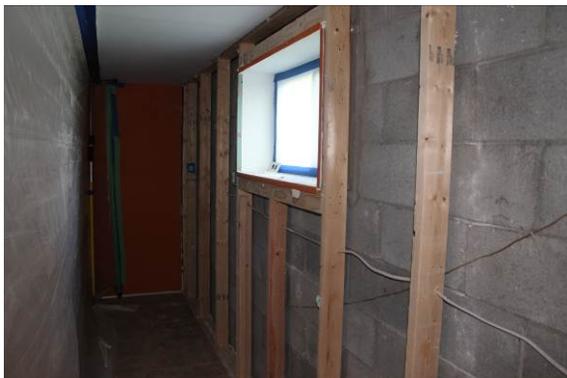
*Basement wall exposed and ready for spray foam.*

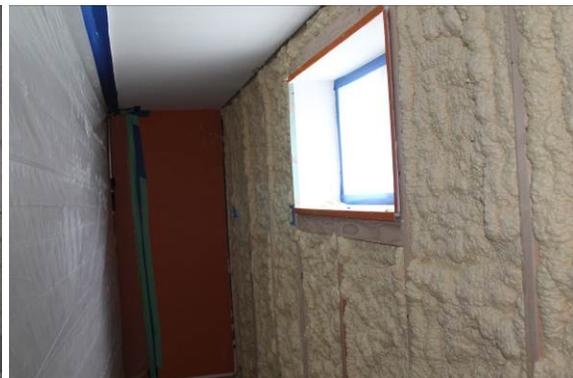
*Spray foam on basement wall. It will need to be trimmed prior to sheetrocking.*

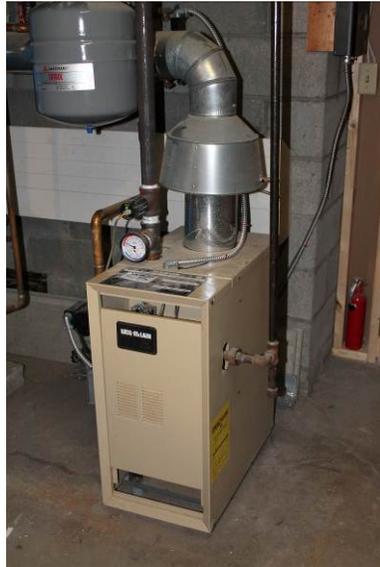
- a) Old boiler flue. The original boiler was an atmospheric boiler with 6" flue. Although it had a motorized vent damper, leakage was still detected through the draft hood. After a sidewall-vented, sealed combustion boiler was installed, the flue was capped at the chimney top, the thimble plugged and caulked, and the cast-iron cleanout caulked shut.

*The existing heating system, a cast-iron, atmospherically vented boiler.*

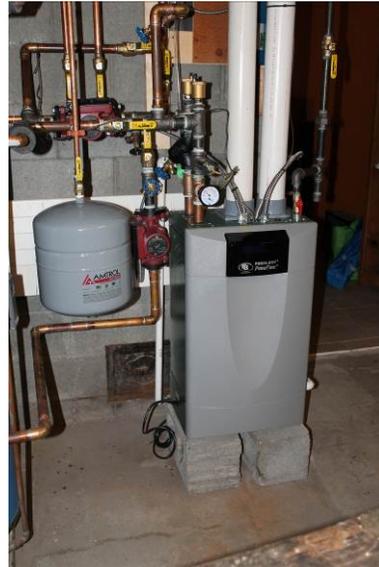
*The new 95% efficient boiler.*

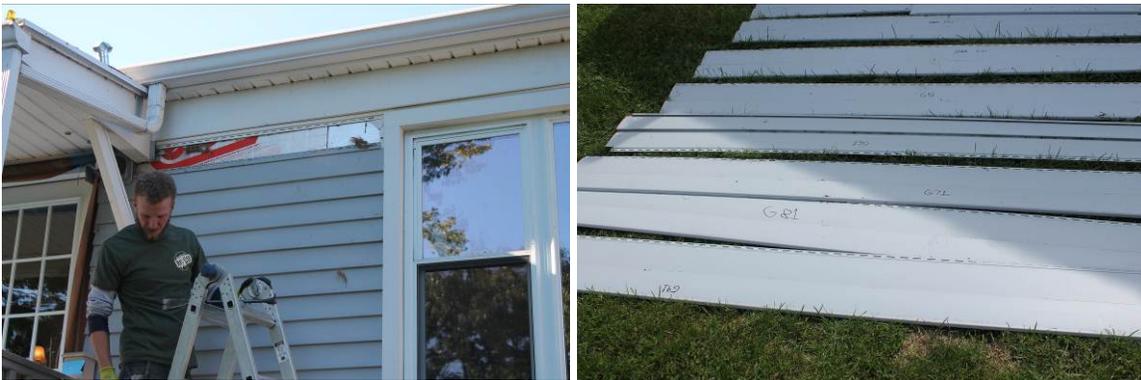
*Finger Lakes Re-Use begins removing the siding. Siding was labeled for re-installation.*

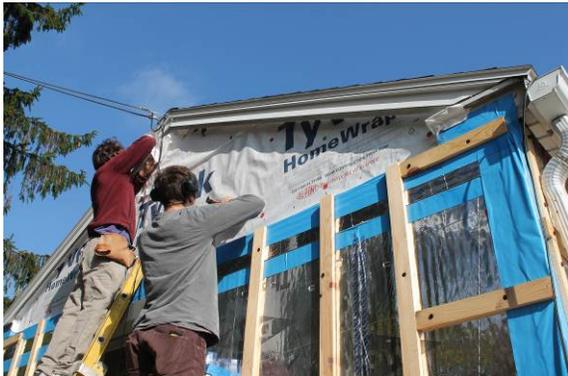
*Detailing the drainage plane on the front gable end.*

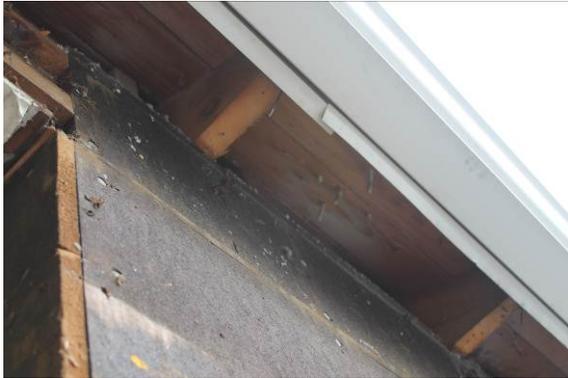
*Soffit boards were removed so the Thermax can extend up past the top plates. We notched around the rafter tails and sealed the wall/ceiling junction with spray foam from the attic.*

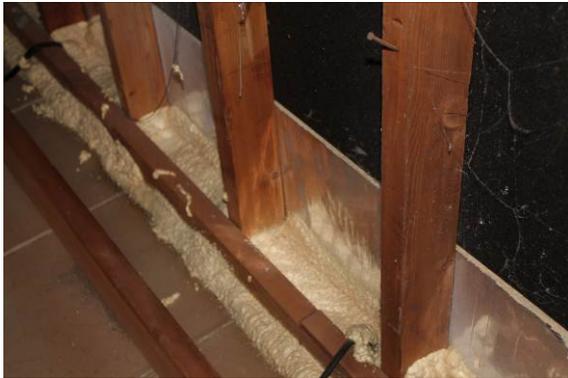
*Spray foam provides a positive seal between top plates and Thermax at the garage wall.*

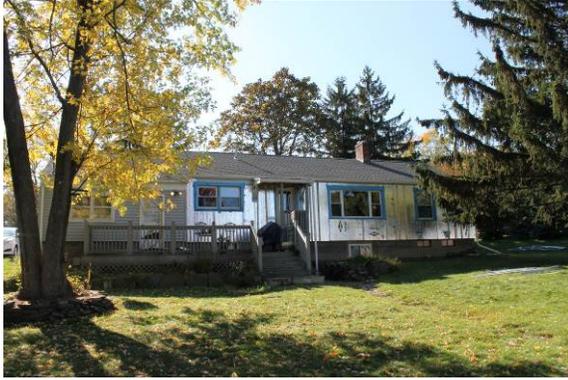
*Taped Thermax and window flashing on rear of house.*

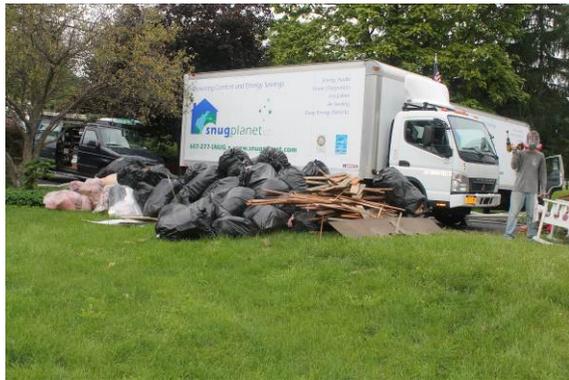
*Post-attic cleanout.*
