# Overview of the NYSERDA QA System and Contractor Evaluation

LIFE Statewide Conference – May 2012

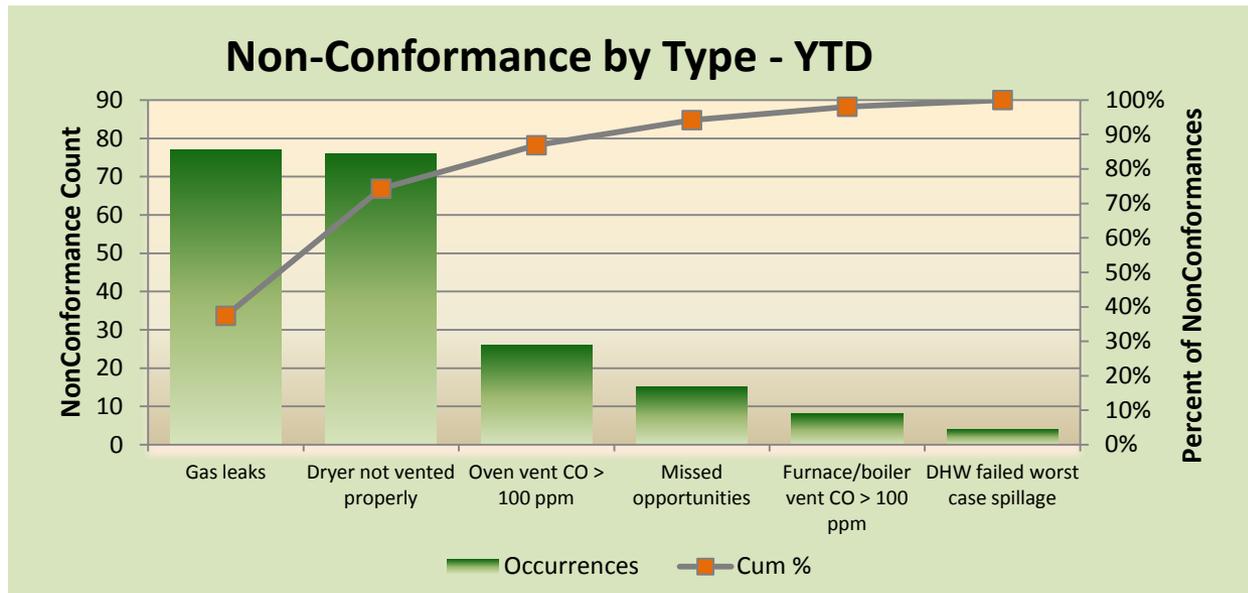
- Across Home Performance projects of all types, the most common non-conformance.

- gas leak rates varied widely by region and QA inspector.

- higher occurrences where equipment lacked sensitivity to detect to 20 ppm (draft BPI Std).

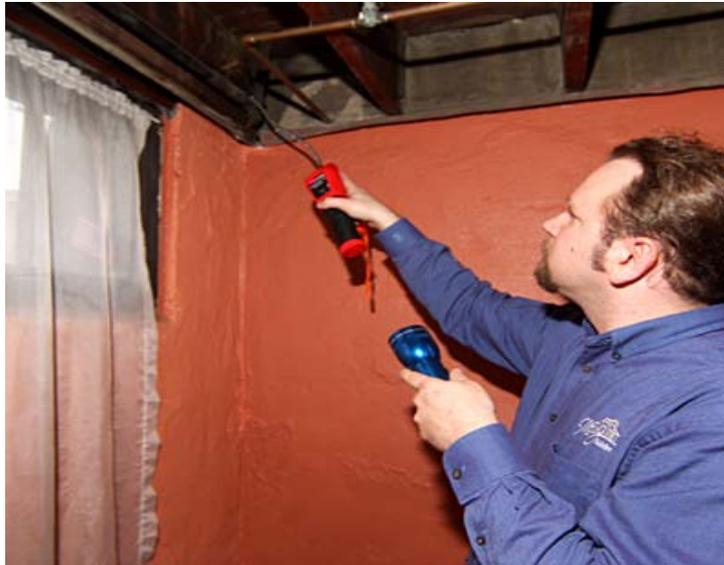
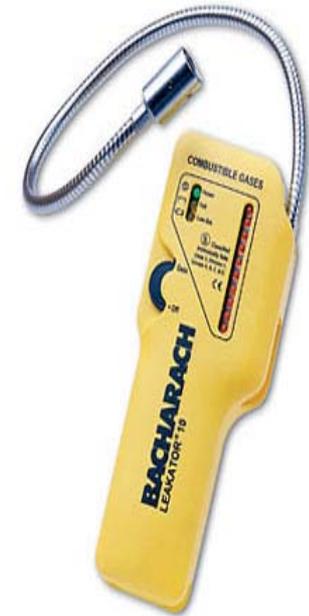
- Proper equipment
- Training

- Gas Equipment Specification Requirements
  - Must detect leaks at 20 ppm or less (methane)
  - Must have a 16 inch flexible probe
  - Must be able to be field calibrated
  - Minimum of 16 hours to a charge
  - Adjustable audio alarm
  - Visual LED or similar output

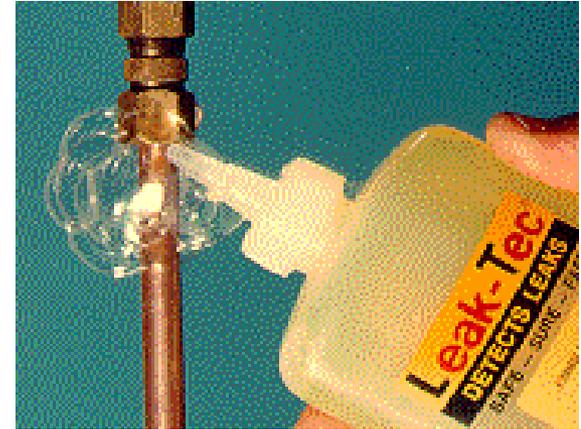
- Training
  - On-site hands on training
  - Webinar
  - DVD
- Training Equipment Incentives
  - Limit up-front costs

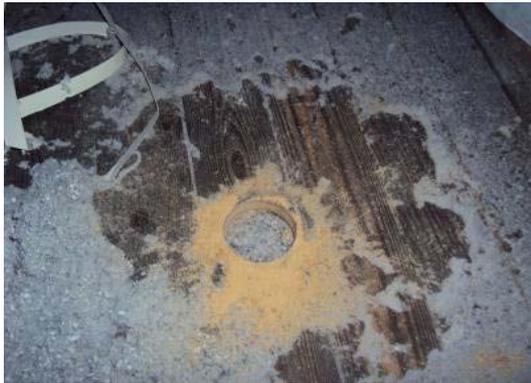
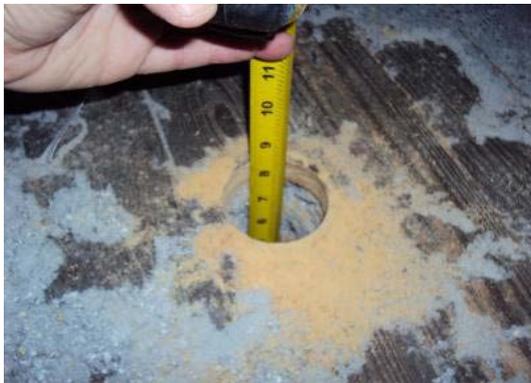
Sample 1 [East]: 9.74 grams with a density of 1.5 lb/ft<sup>3</sup>

- Dense pack installation failures
  - Improper installation techniques
  - Inadequate pressure
  - Failure to take the necessary time

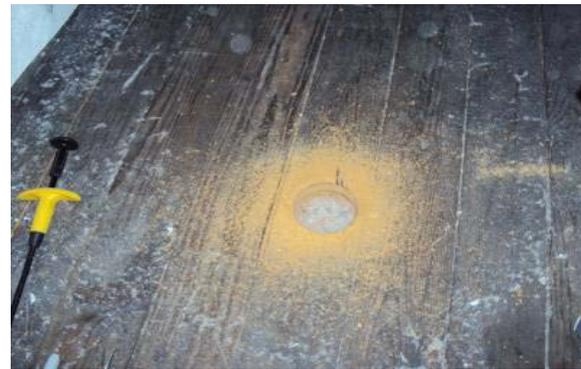
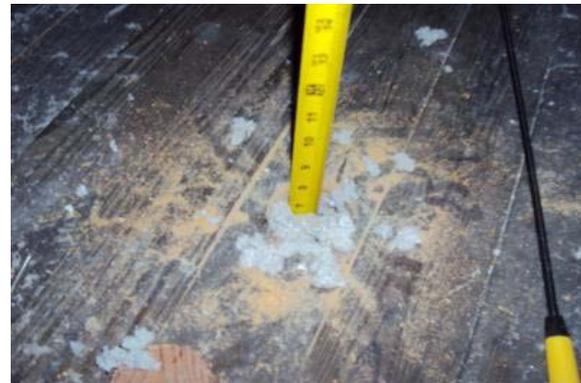
Sample 2 [West]: 13.13 grams with a density of 2.1 lb/ft<sup>3</sup>
