**ADIRONDACK ALTERNATE ENERGY  
PASSIVE SOLAR HOUSES AT HYPOT AND KILMER**

**FINAL REPORT 10-27  
NOVEMBER 2010**

**NEW YORK STATE  
ENERGY RESEARCH AND  
DEVELOPMENT AUTHORITY**

Final Report

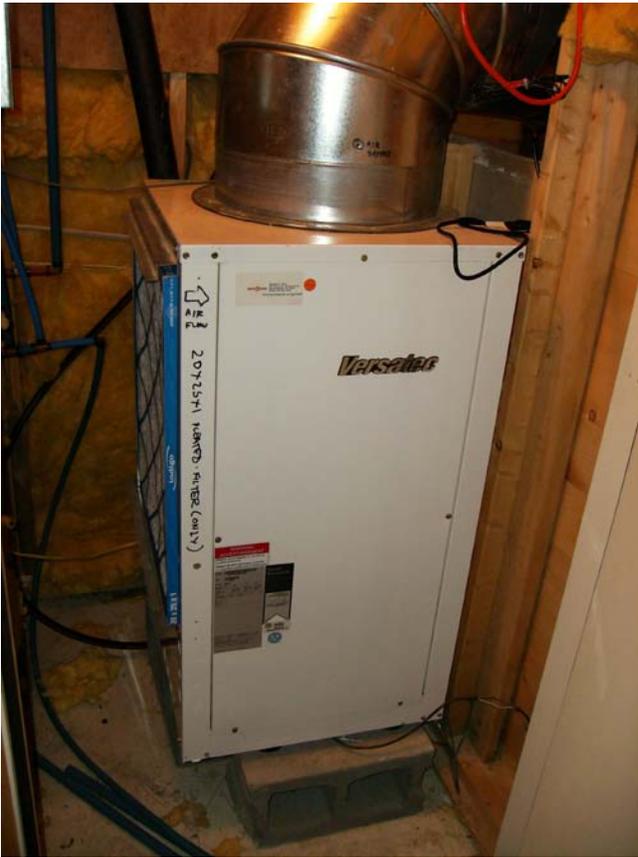
Versatec Water-Source Heat Pump

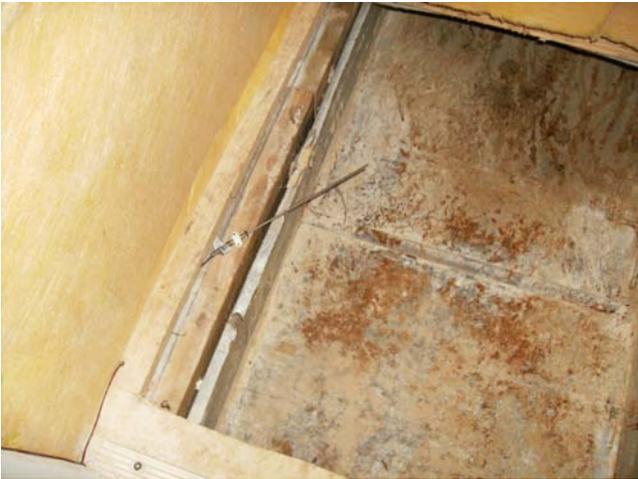
Supply Duct Leaving Bottom of Plenum (entering slab)

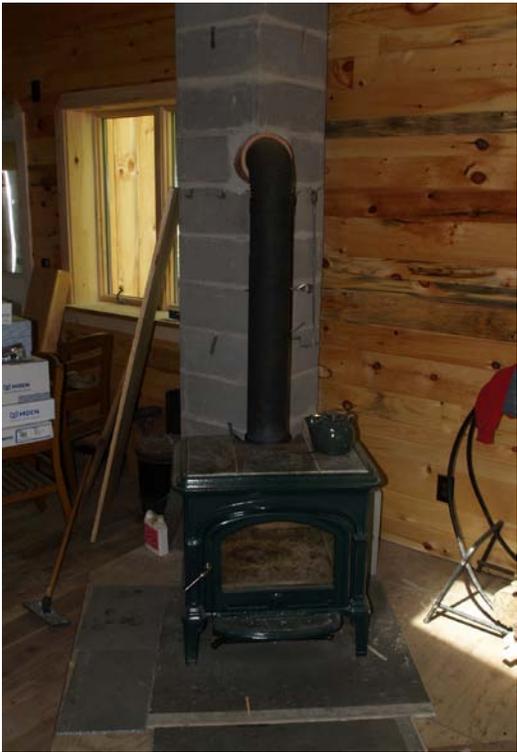
Wood Stove in Main Part of Home

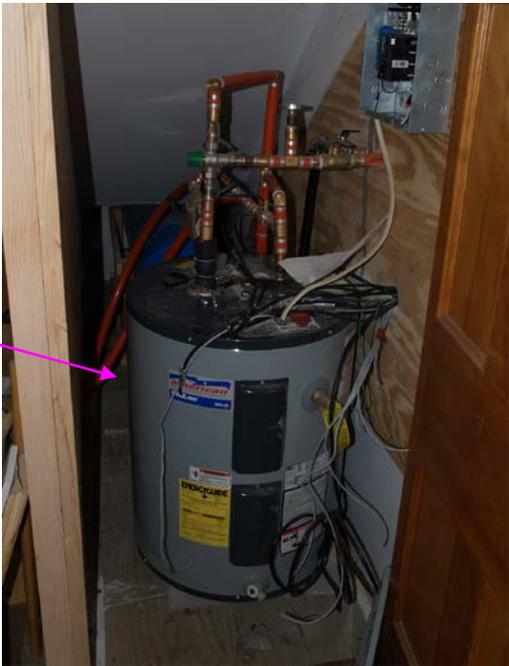
20-gallon DHW Tank

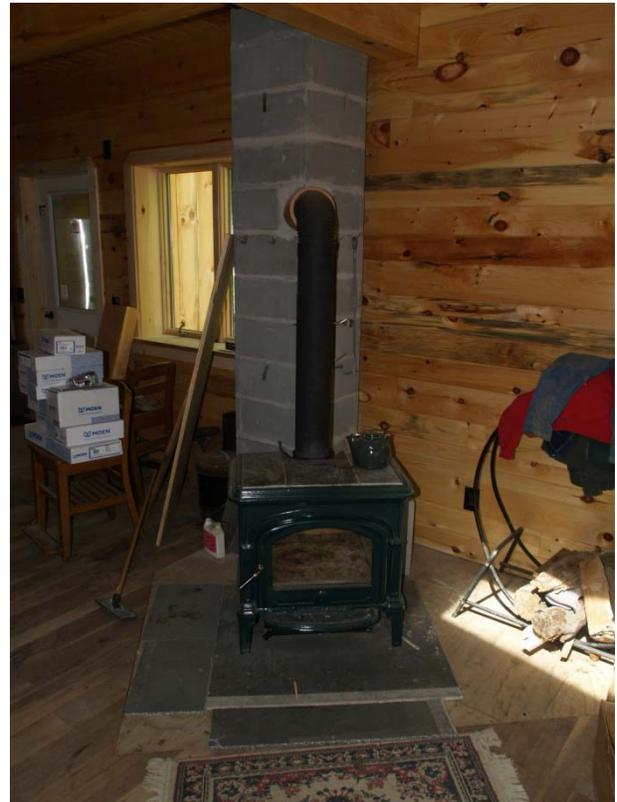
Bloor Door installed in South Door

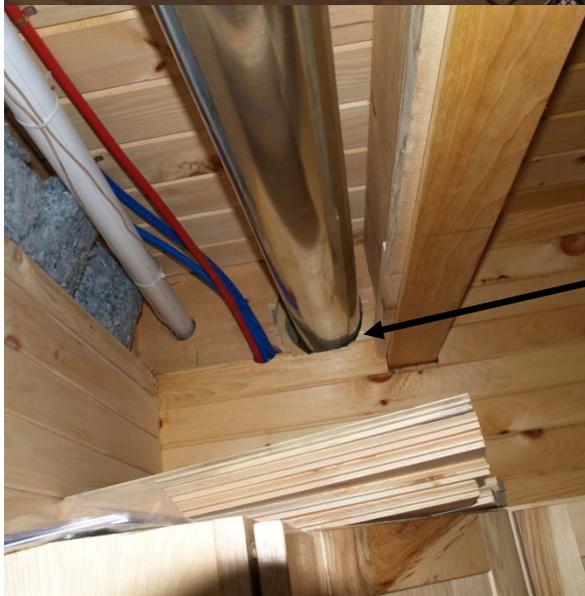
Penetrations between Kitchen and 3-Seasons Room

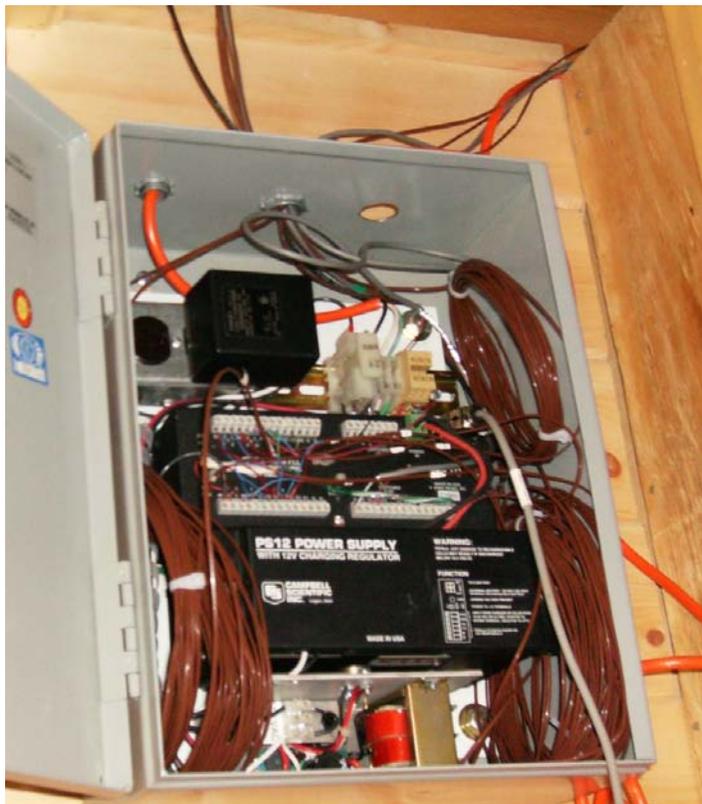
Figure 45. CR10x Installed in Bathroom above Toilet

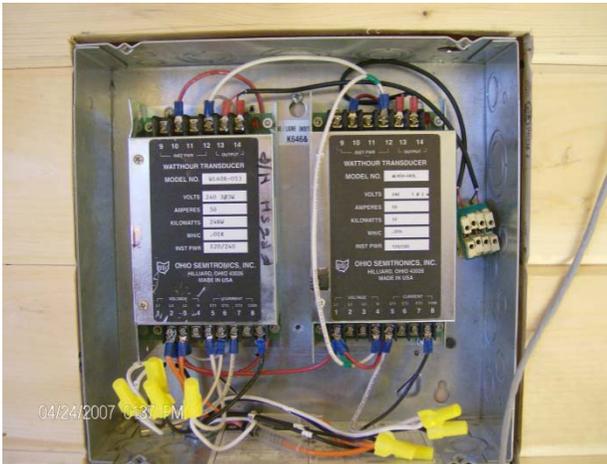
*Transducer Panel in Northwest Room*

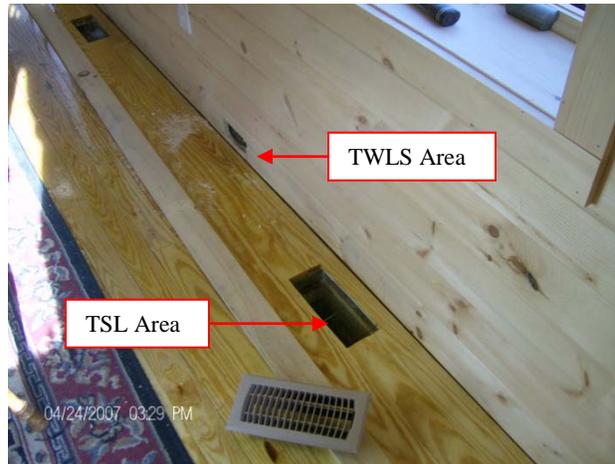
*Locations of TSL and TWLS – South Interior Wall*

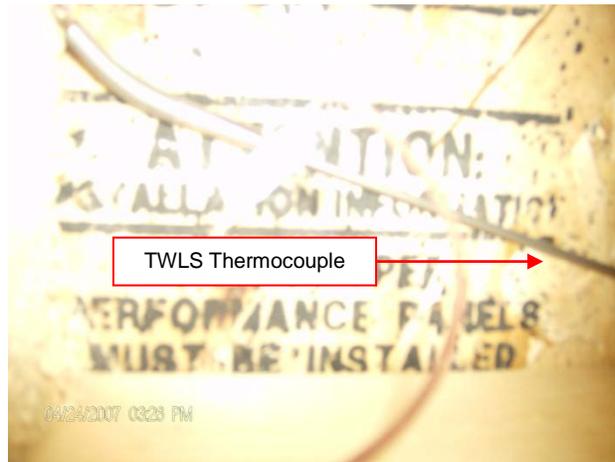
*TWLS at the South Interior Wall*
