# Optimized Strategy for Scaling Up Deep Energy Retrofit

## West Hill House

Revised with Data Monitoring: February 11, 2013

Revised with Updated Costs: February 25, 2013

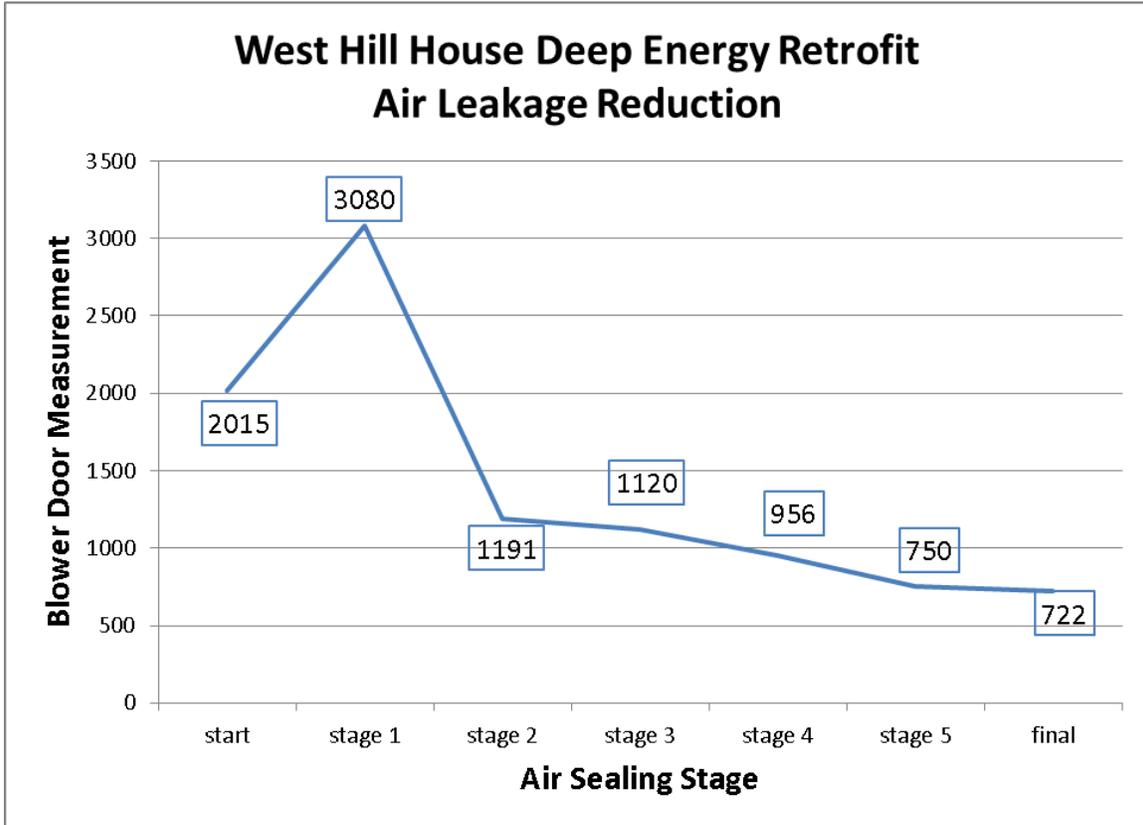
Blower door measurements were taken at several stages during the air leakage reduction process. The graph below shows the measurement at each stage, followed by a table listing the work completed during the stage.

Air Sealing Stage	CFM50	Work completed
Start	2015	
Stage 1	3080	<ul style="list-style-type: none"> <li>vinyl siding &amp; old foam sheathing removed</li> <li>walls dense packed</li> <li>attic fiberglass removed</li> </ul>
Stage 2	1191	<ul style="list-style-type: none"> <li>attic airsealed</li> <li>band joists spray foamed</li> </ul>
Stage 3	1120	<ul style="list-style-type: none"> <li>wall foam installed</li> </ul>
Stage 4	956	<ul style="list-style-type: none"> <li>sealed fan ducts and exterior top plates</li> </ul>
Stage 5	750	<ul style="list-style-type: none"> <li>Lock top damper, window flashing</li> </ul>
Final	722	<ul style="list-style-type: none"> <li>Final round of blower door guided air sealing, mostly basement sill and band joist</li> </ul>

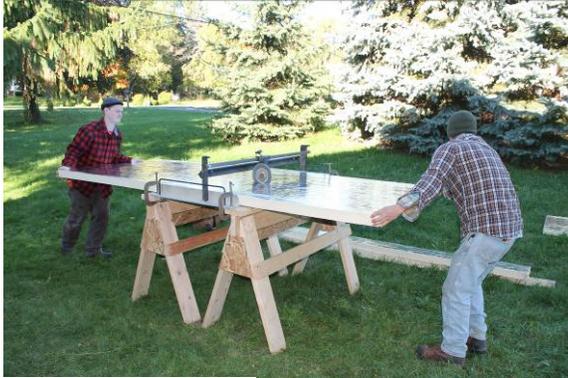
*Using the Accucutter.*

- Utilize the Accu-cutter. This allowed the foam sheathing to be cut quickly and with very tight tolerances.

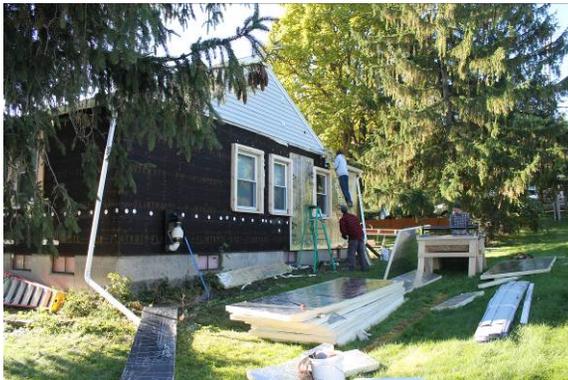
*Thermax being installed.*

- a) 4" Wind-Lock screws were used to attach Thermax sheathing to wood-frame walls.
- b) The number of screws per sheet was reduced from the manufacturer's recommendation of 28-30 per full sheet to 12 per full sheet. This seemed to provide very secure attachment. In this house, the siding contractor decided to attach  $\frac{3}{4}$ " furring strips with 5" Head-lok screws over the Thermax. The Head-lok screws went directly into the studs. This was done because it was determined that the original fiberboard siding would not reliably hold siding nails; it also provided an extra-secure attachment for the Thermax.
- c) Where possible, a single Wind-Lock screw was used to span the joint between two sheets of Thermax.

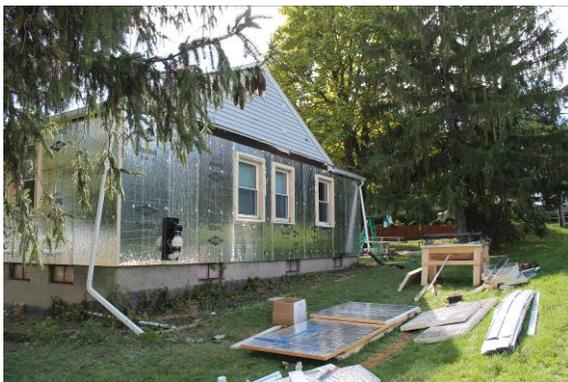
*Thermax installed. Note Accu-Cutter on sawhorses at right.*

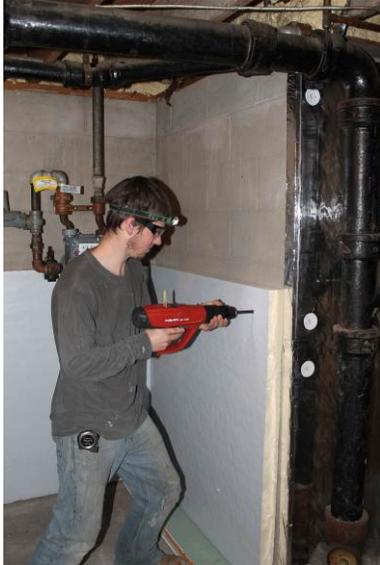
*Using the Hilti to attach Thermax to basement wall.*

- a) Despite the lower installed cost of the Christmas tree fasteners, the crew expressed a strong preference for the Hilti fasteners, both because of the tighter connection to the wall and the reduced physical effort of installation. The Hilti fasteners were selected for this project and performed well. Six fasteners were used per full sheet.

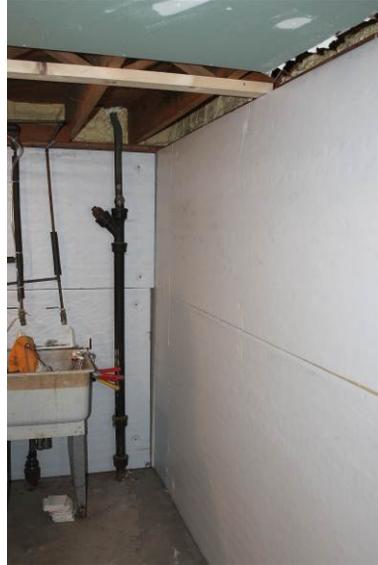
*Basement wall with Thermax, not yet taped.*

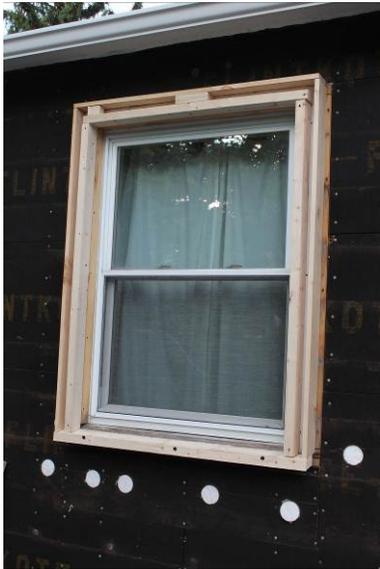
*Window buck.*

- a) The buck and flashing approaches tested in the Time and motion were designed for new, flanged windows. The windows in this project were existing vinyl inserts which were left in place. The windows were flashed as “innies,” with wooden jamb and sill extensions built outboard of the existing window trim. Straight flashing was used to wrap the sill and sill extension. We developed a technique for slitting the release paper longitudinally which allowed us to tuck the unadhered portion of the straight flashing up under the sill angle and to adhere it to a second piece of straight flashing below. Straight flashing was also used for the side and head flashings, and a piece of Weathermate construction tape was used to protect the head flashing from low-angle shear per Building Science Corp. recommendations. The straight flashing worked well, although in a few places it was not tucked tightly into corners and interfered with installation of aluminum window trim. In future installations of this type, the straight flashing should be pressed tightly into corners with a tool that will not cut or rip the straight flashing.

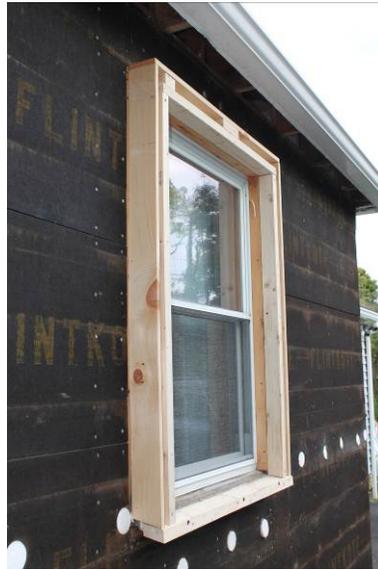
*Window buck, alternate view.*

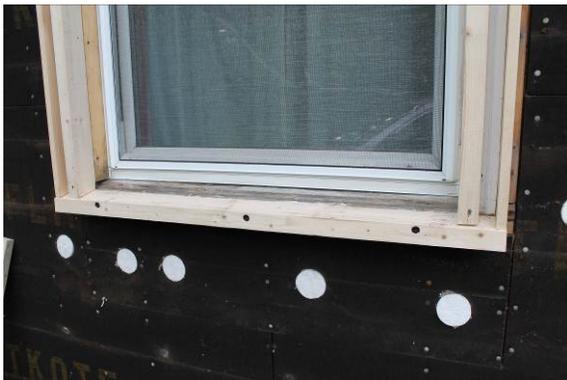
*Sill extension detail.*
